PLAN UPDATES FOR POWER BOATS UNDER 16'

GV11 PLANS UPDATE

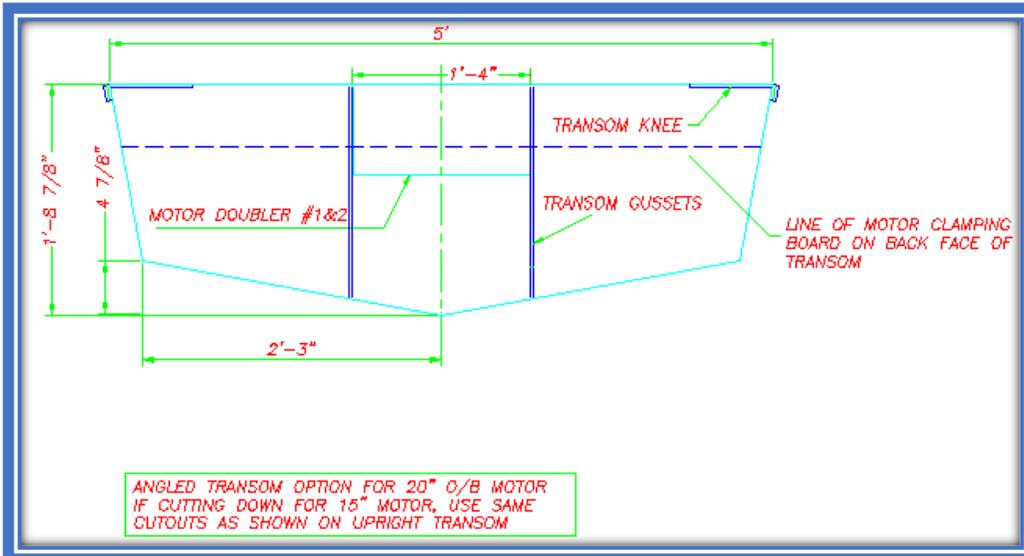
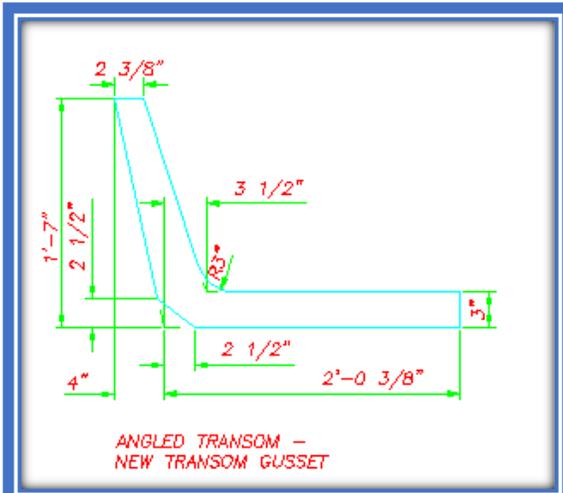
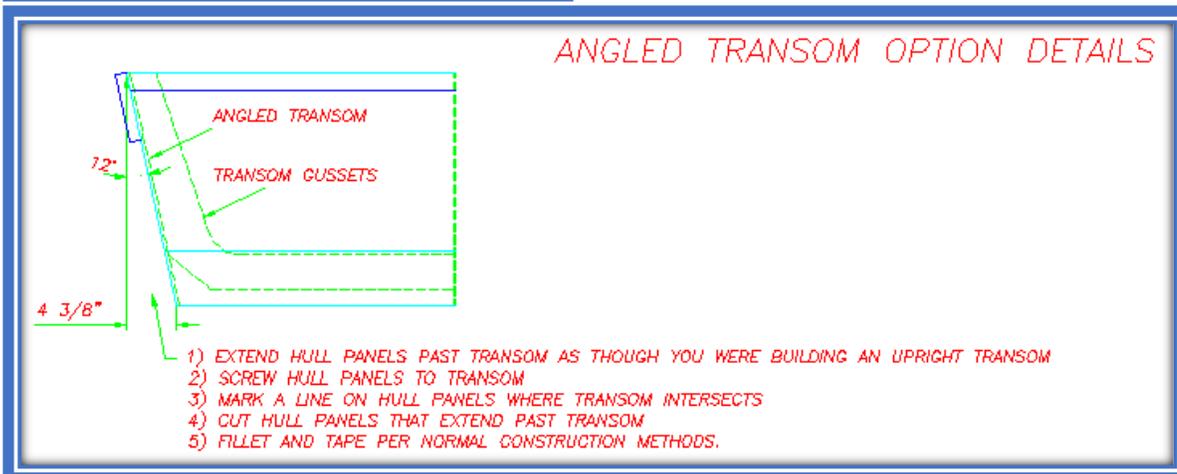
Some people have asked for an angled transom option for the GV11 - here are the revised transom and transom gusset dimensions.

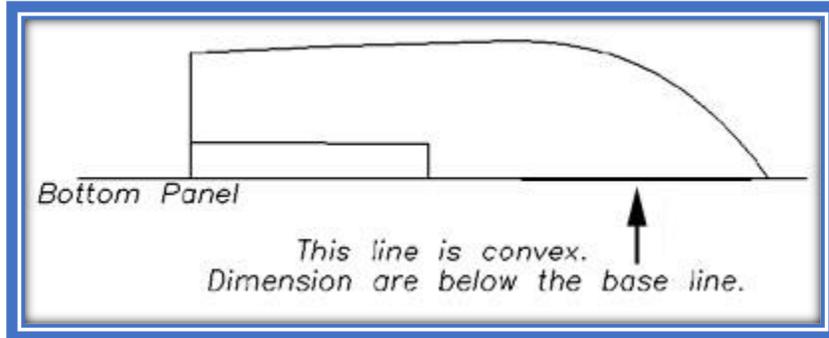
For all plans received before June 2004. Please read the bottom panel dimensions carefully. See drawing below.

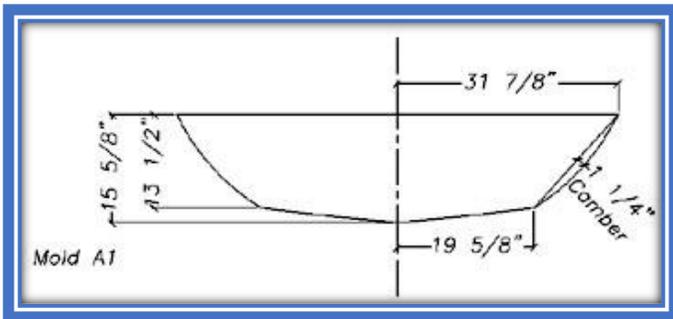
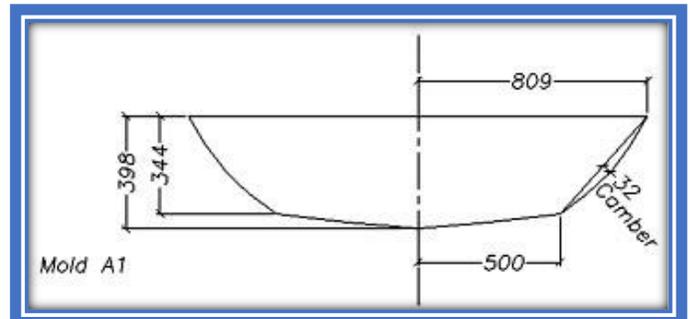
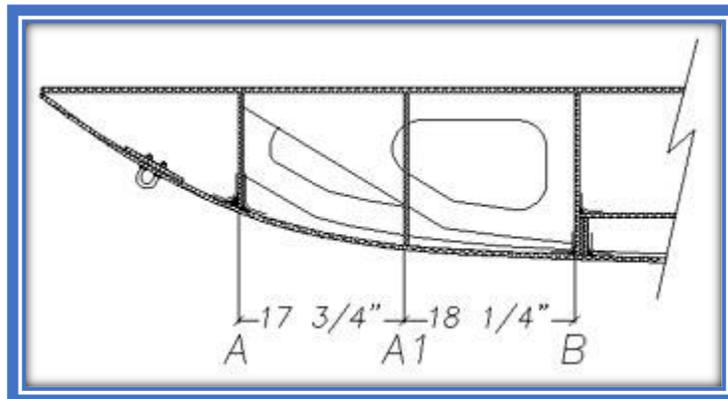
In the Building Notes there is a mold between frames A & B. We forgot to include the dimension of the mold in the first few set of plans. The mold is important to produce the correct hull shape. See below for the dimensions and the location.
