Plywood Composite Testing

Except for our very small boats, most of our designs use composite panels for the hull planking. Those panels are made of a plywood core sandwiched between layers of directional fiberglass in epoxy resin. While the boat is assembled like a plywood boat, the final product is a true sandwich composite hull, strong and lightweight. On this page, we show the difference in strength between those two materials. When building our boats, it is important to understand that difference. If not, the builder may focus on wooden boat building techniques and neglect the fiberglass work or worse, substitute inadequate materials. Our scantlings (material selection and size) are based on plywood-epoxy-fiberglass panels tested by a local laboratory in 1991. Those tests were made in accordance with ASTM standards and measured tensile, flexural strength, related moduli and resistance to shear. We do not have any pictures of those tests and materials evolved therefore, we ran a batch of simple tests on our home-made test bench. The purpose of the tests was to compare the properties of plywood with and without our fiberglass skins, not to extract absolute values.

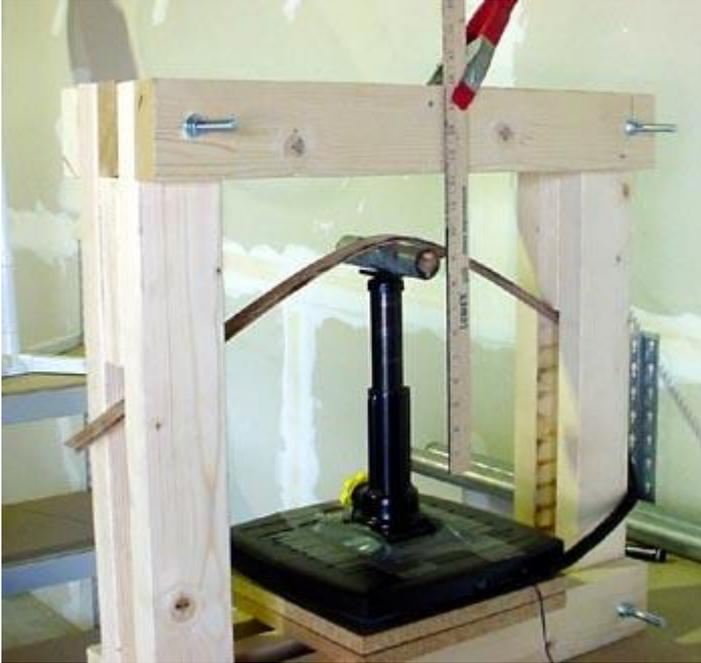
Our samples were made of thin 6 mm (1/4") plywood with or without glass. For the sandwich panels, we used only one layer of glass but in many of our boats we use thicker plywood and several layers of glass. For example, 3 layers each side plus all the overlaps of stringers etc. can end up to a total of 12 layers.

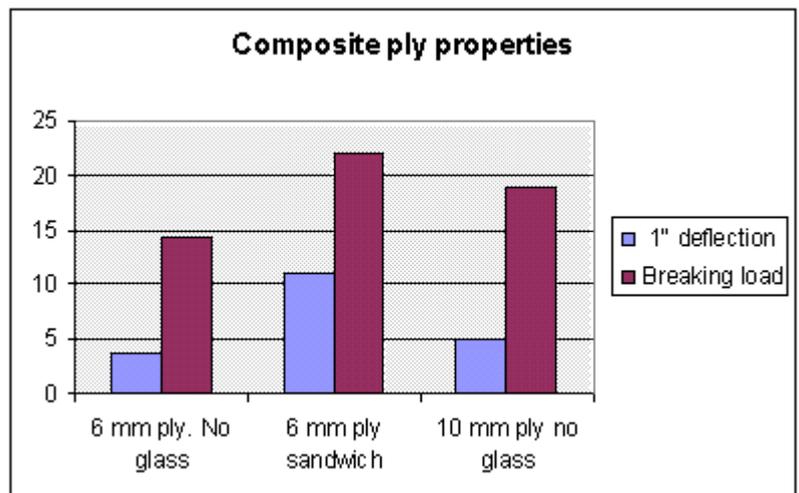
We compared flexural and tensile strength by measuring the pressure needed to deflect the samples 1" and the pressure required to break the panels. We tested 10 samples of each type. The sandwich panel is in the sample in the middle. See the blue lines for flexion: the composite sandwich is around 3 times stiffer than the plywood and two times stiffer than thicker 10 mm (3/8") plywood. Previous tests have shown that it is stiffer than 1/2" plywood! The purple lines show the ultimate strength or more exactly, the pressure required to reach catastrophic failure. The composite sandwich is almost two times stronger than the plywood without glass and still significantly stronger than 3/8" plywood. The previous tests showed that it was equal or close to 1/2" plywood. We clearly see that our composite sandwich is very different from plywood and that comparisons based only on the plywood thickness make no sense. It must be noted that we tested samples with one layer of glass only and often, our plans specify several layers. Final notes: the type of resin and fiberglass is very important. A similar sandwich made with polyester resin would be much weaker because of the poor bonding properties of that resin. The type of fiberglass is also important. The designer must specify the appropriate fiber direction. In this case, the 45/45 fiberglass fibers complement the 0-90 fiber orientation of the plywood. A sandwich made with plain woven (0-90) fiberglass would be much weaker.

It must be noted that we tested samples with one layer of glass only and often, our plans specify several layers. Final notes: the type of resin and fiberglass is very important. A similar sandwich made with polyester resin would be much weaker because of the poor bonding properties of that resin. The type of fiberglass is also important. The designer must specify the appropriate fiber direction. In this case, the 45/45 fiberglass fibers complement the 0-90 fiber orientation of the plywood. A sandwich made with plain woven (0-90) fiberglass would be much weaker.
